PROPERTY CONDITION REPORT

Ascend South Creek
3060 Southcreek Boulevard
Orlando, Florida 32824

August 2, 2022
Partner Project Number: 22-378483.2

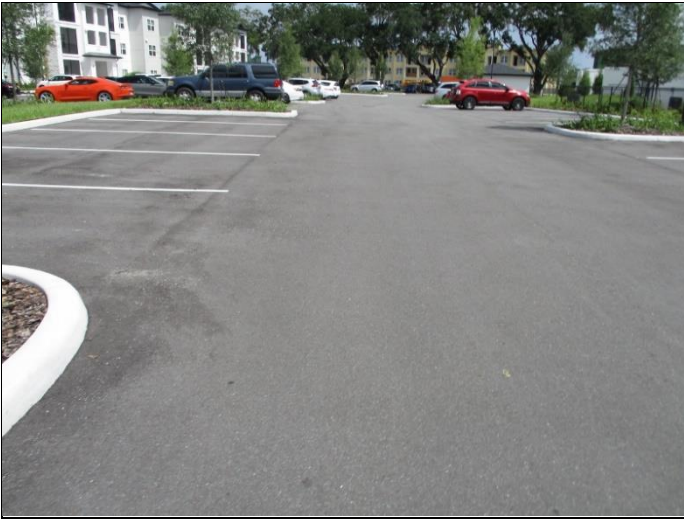
The pavement appeared to be in good structural condition. Routine maintenance is anticipated during the evaluation period.

Asphalt seal coat appeared to be in good condition. Reapplication of the seal coat is anticipated during the evaluation period. An opinion of cost for this work is included in Table 2.

7. Asphalt pavement driveways and parking areas

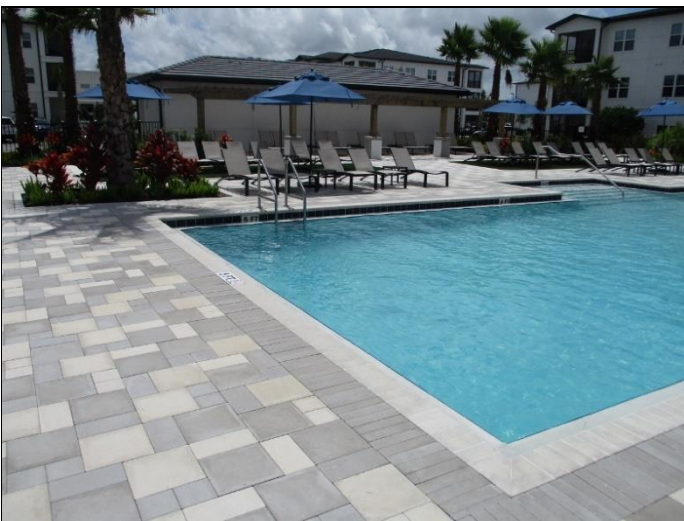
The swimming pool appears to be in good overall condition. No damage was observed or reported by property management. Based on EUL, budgeting for resurfacing and equipment replacement over the evaluation period is advised and included in Table 2.

17. Outdoor swimming pool adjacent to clubhouse building

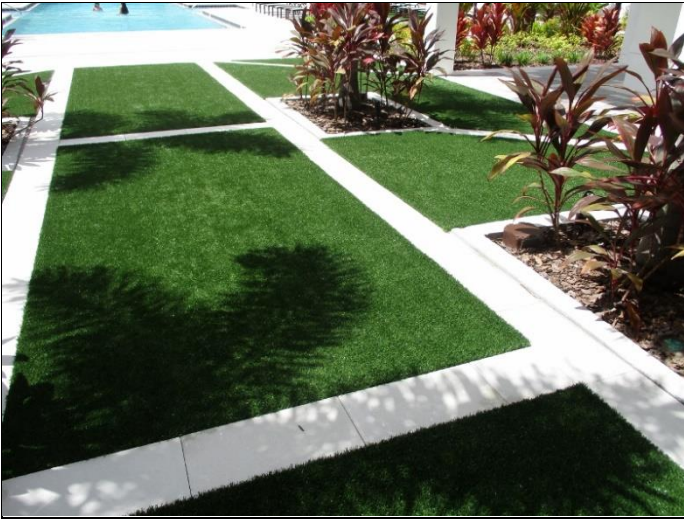
19. Faux lawn and landscaping at pool decking

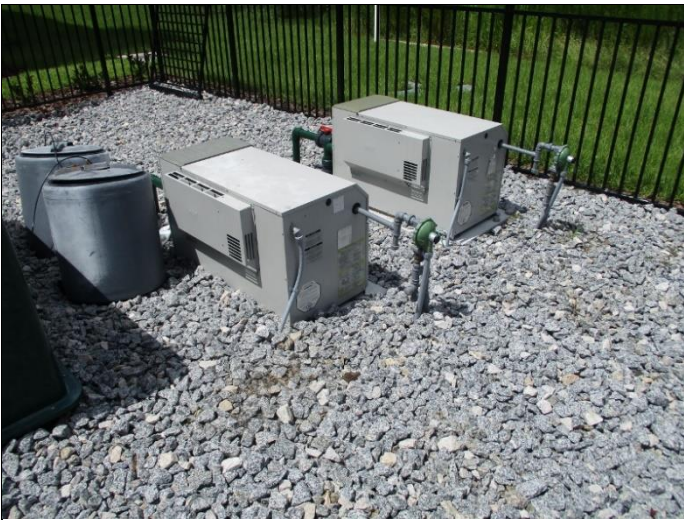
21. Gas-fired pool heaters

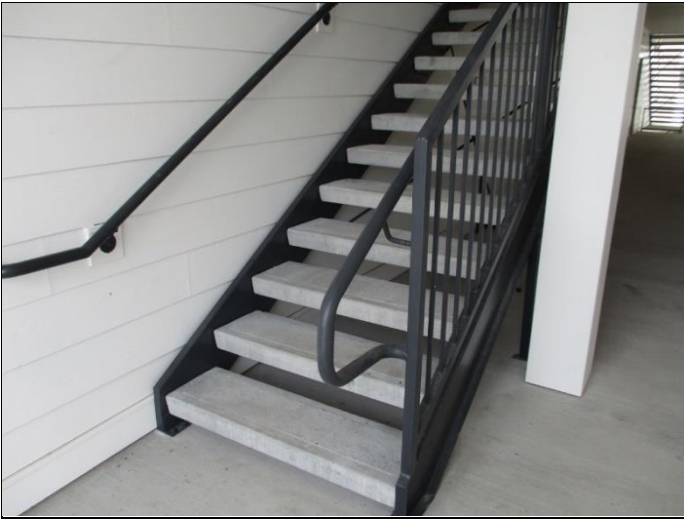
Stairs and balconies appear to be in good condition. Routine maintenance is anticipated throughout the evaluation period. Replacement of elastomeric coatings is anticipated during the evaluation period. The cost for this work can be performed as part of routine maintenance. Painting of the stairs, balconies and guard rails can be performed in conjunction with the painting of the building exterior and interior common areas.

25. Exterior breezeway stairs

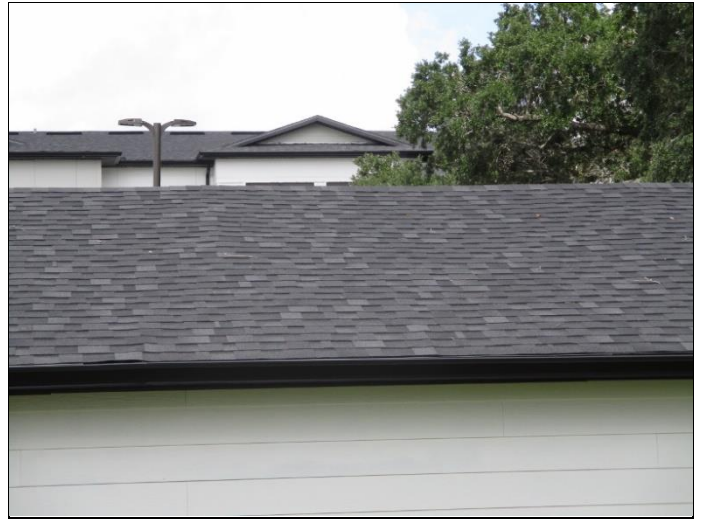
The roofing systems appear to be in good overall condition. According to property management, the shingles are the originally installed system and are less than one year old. Based on our observations, the reported age appears to be reasonable. Roof leakage was not observed and or reported by property

26. Pitched asphalt composite shingle roof finishes

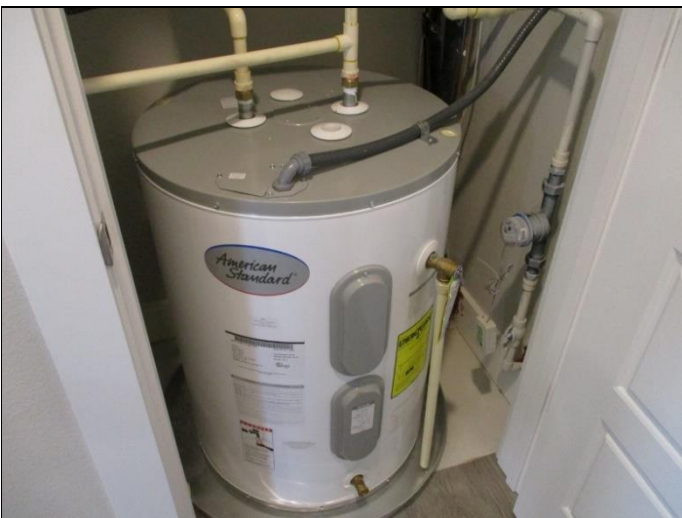
35. Electric hot water heater at each unit

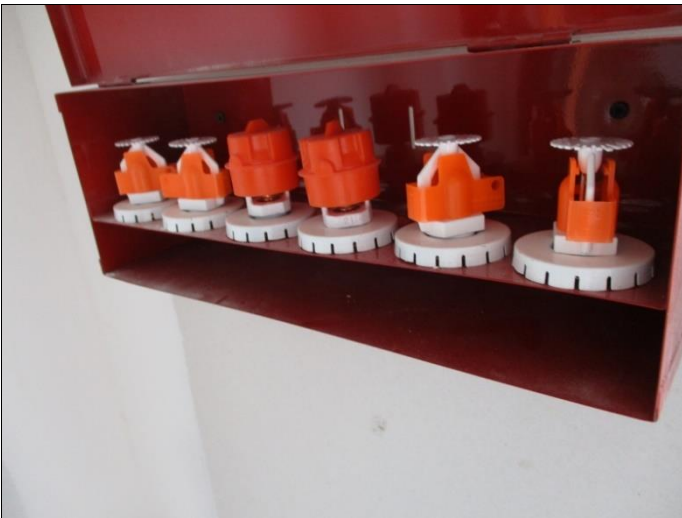
39. Replacement fire sprinkler heads

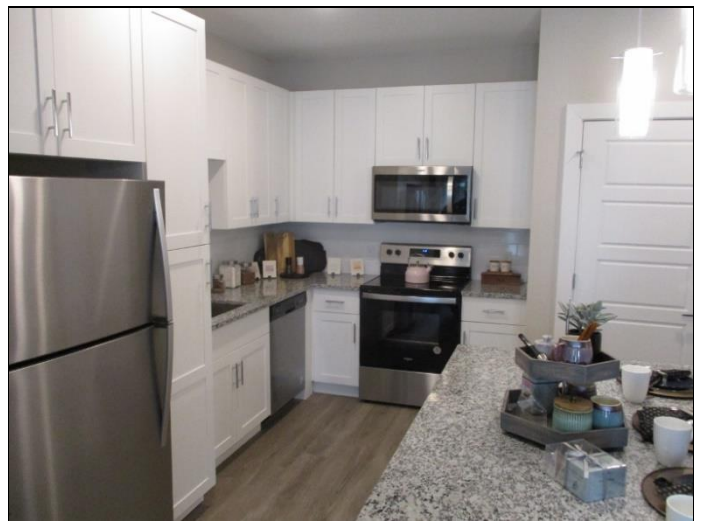
4.0 Structural Frame and Building Envelope					
	None Noted				
5.0 Mechanical and Electrical Systems					
	None Noted				
6.0 Interior Elements					
6.5.3	It appears the heat from the electric range-oven tops is damaging the kitchen cabinet doors on the either side of the range-ovens in the apartment units. Partner anticipates replacement of the kitchen cabinet doors on either side of the apartment unit range-ovens in the near term. Additionally, Partner recommends that property management check the calibration of the range-oven tops to ensure they are set at a heat level that will avoid further damage to the cabinets.	600	Unit	\$175	\$105,000

54. Resident kitchen area
