LIMITED PLUMBING & ELECTRICAL SYSTEM ASSESSMENT REPORT

One on 4th

713 W. 4th Avenue
Stillwater, OK 74074

Partner Project Number: 22-362181.4

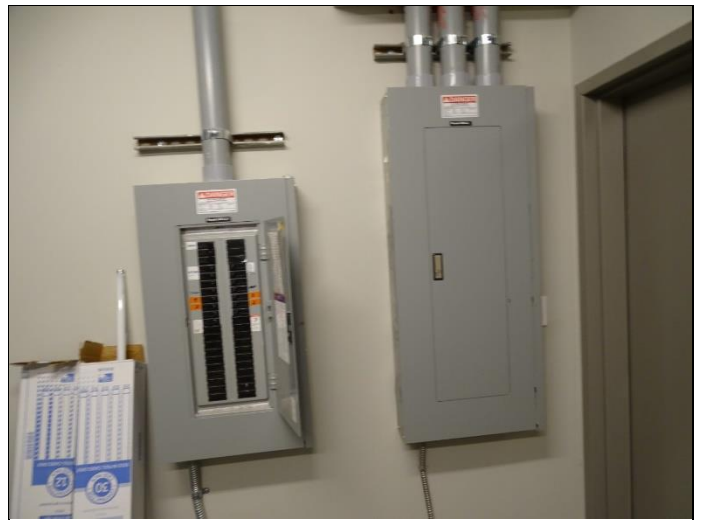
4. Panels tested

During the on-site assessment, Dane & Associates Electric, inspected the lighting systems, several panelboards, and performed line voltage measurements at several connections to determine whether line voltage was within range. The national standard for utility voltage tolerance in North America is ANSI C84.1. This standard establishes nominal voltage ratings and operating tolerances for 60Hz electric power systems above 100 volts. End user equipment should be designed to provide acceptable performance for voltages

in Range B from ANSI C84.1. The tolerance for range B utilization voltage is +5.8% to -13.3%. All line voltages measured during the follow-up assessment were within this range. No concerns with regard to conductor sizing were identified from panelboard inspections either. All wiring was found to be copper.

Based upon the findings of our follow-up assessment, no further corrective action seems warranted for the common corridor lighting systems at this time. It is recommended that spare ballasts for common area lighting systems be kept in the maintenance inventory in the event other ballast failures occur in the future. This should be done as a routine maintenance best practice.

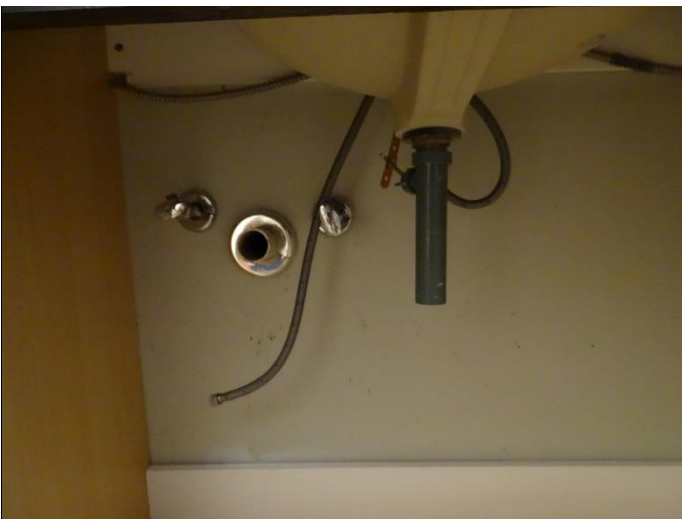
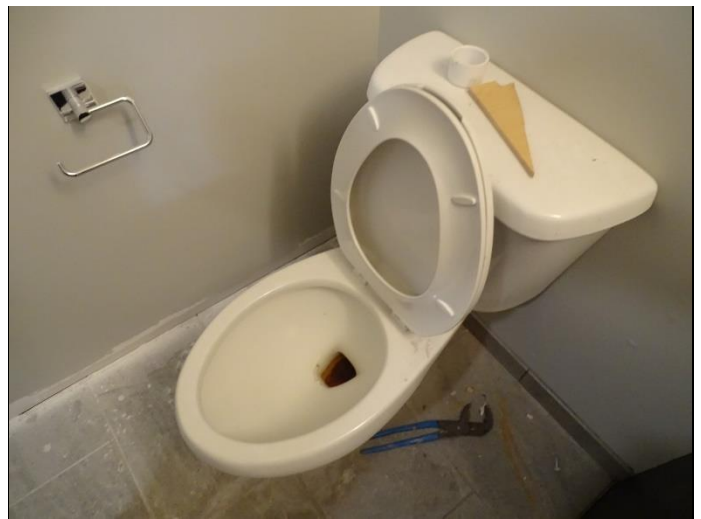
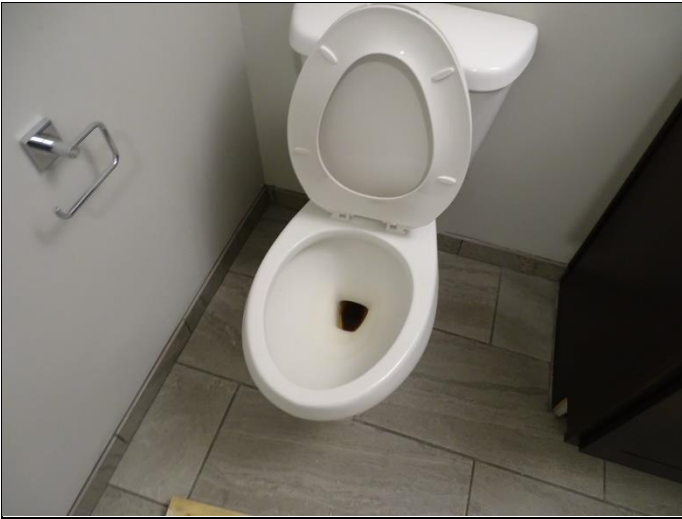
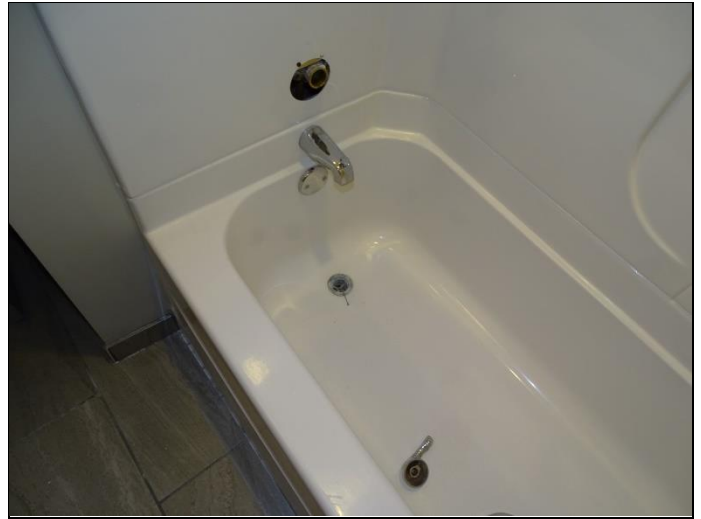
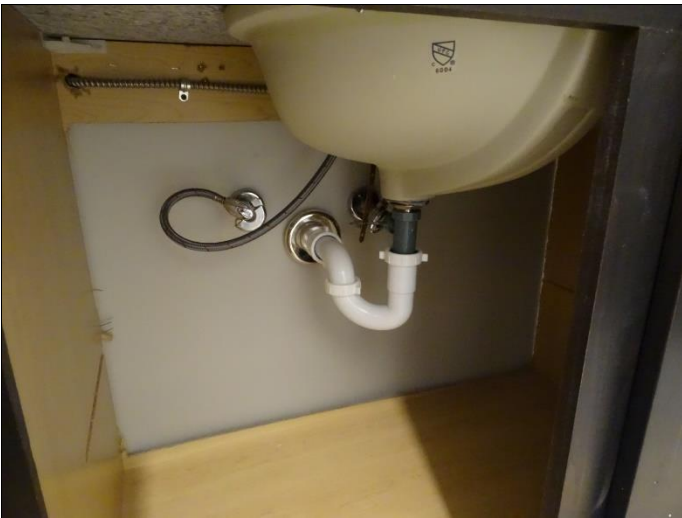
The sanitary and vent piping systems at the facility consist of PVC. After reviewing the plumbing as-built drawings, it appears there is a 4" main line in each apartment demising wall which branches off to 1 ½ and 1 ¼-inch lines. Prior plumbing leaks were reported in Apartment Units 017 and 207.

According to our prior assessment, "Maintenance staff reported that the PVC piping had separated from the PVC fittings causing a sanitary sewer line leak that caused damage to the drywall at the ceiling. It was reported that this same situation has occurred at several other locations within the subject building where sanitary sewer lines had disconnected."

The wall and ceiling area that was damaged by the prior plumbing leak was repaired and all plumbing was concealed by the time we went on-site. It was reported that the sewer issue was related to a plumbing blockage that put stress on the system. It was reported that Roto-Rooter conducted a camera inspection to find a blockage and removed it.

5. Apartment 017, plumbing

Based upon our on-site observations and findings from the follow-up site inspection as well as the pervasiveness of the sanitary sewer leaks that have developed in the past, it is recommended that an annual allowance of \$10,000/year be allocated toward ongoing plumbing repairs during the next 10 to 12 years. This allowance would be intended to cover miscellaneous plumbing repairs and/or drywall repairs caused by future sanitary sewer leaks. A program of comprehensive sanitary sewer piping repairs or replacements does not seem warranted at this time based upon the limited number of incidences reported in the past and the fact that some of the water damage was caused by an unrelated issue with the fire suppression systems serving Juliette-type dwelling units freezing (See Section 3.2 for more details).
