PROPERTY CONDITION REPORT

Ascend South Creek
3060 Southcreek Boulevard
Orlando, Florida 32824

August 2, 2022
Partner Project Number: 22-378483.2

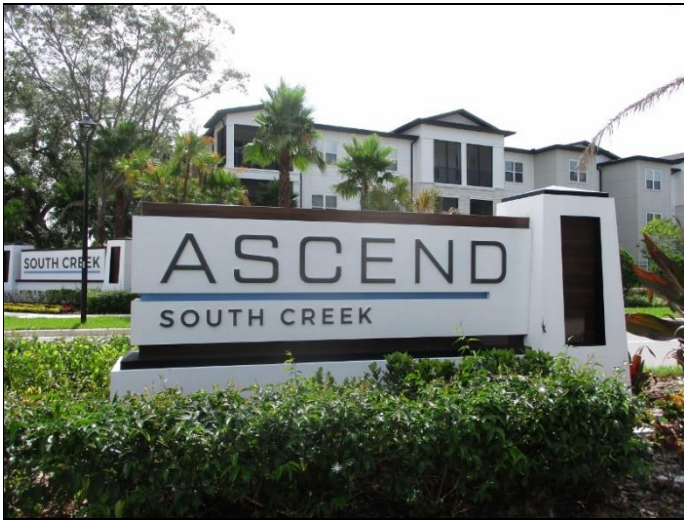
1. Monument signage at entrance driveway

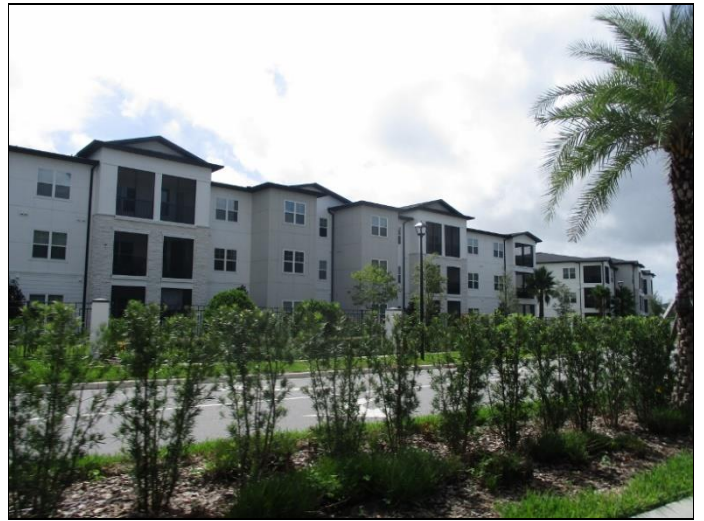
2. Apartment front elevation

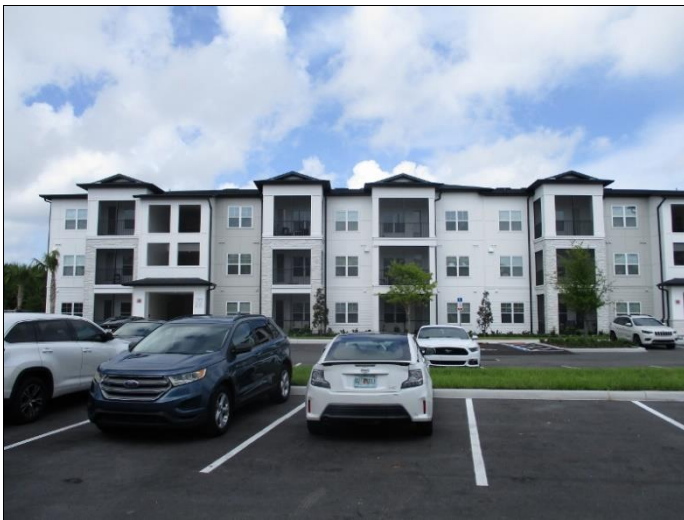
3. Apartment front elevation

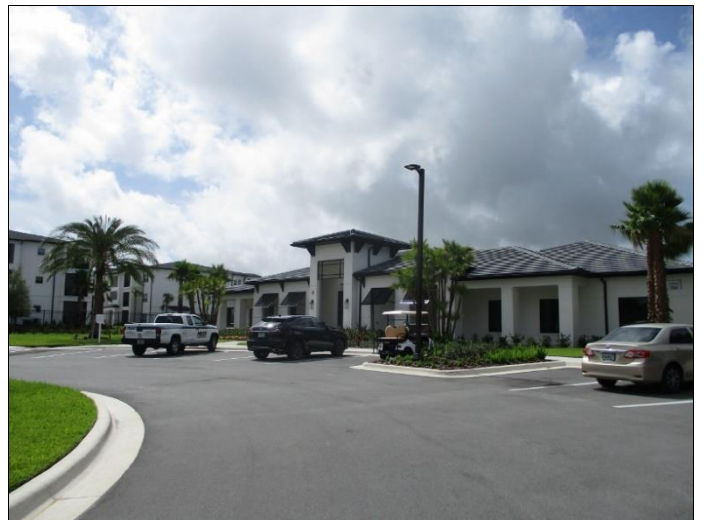
4. Clubhouse elevation

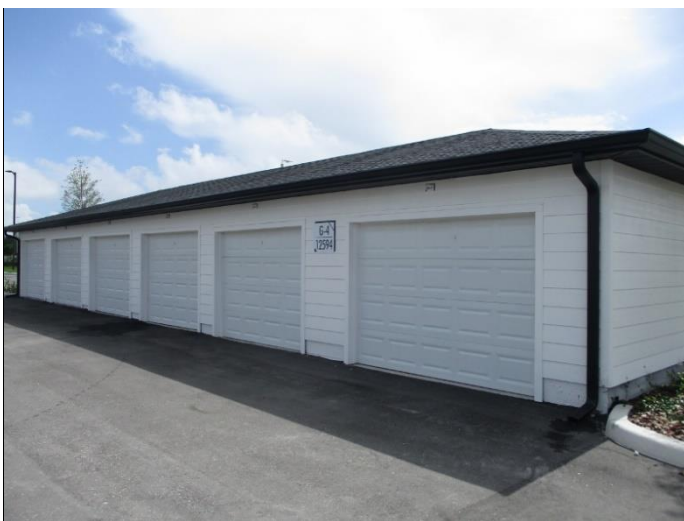
5. Garage building elevation

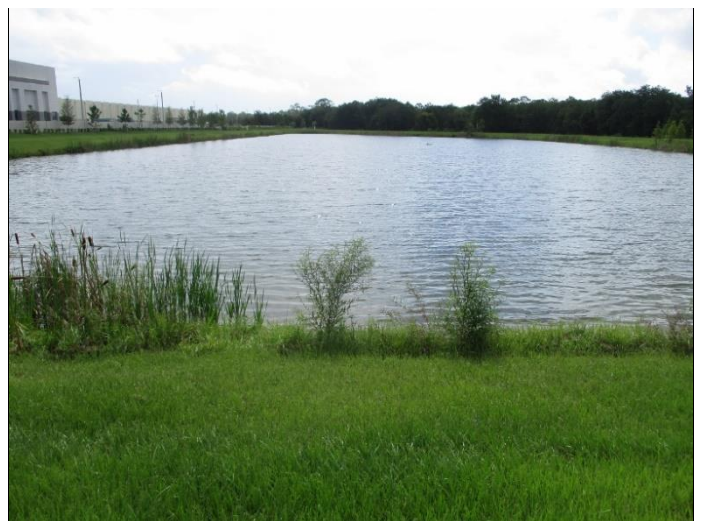
6. Southeast retention pond

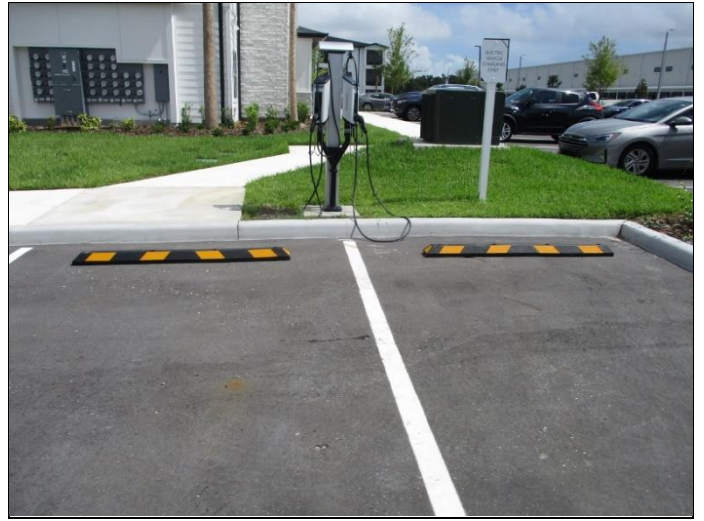
8. Electric vehicle charging station

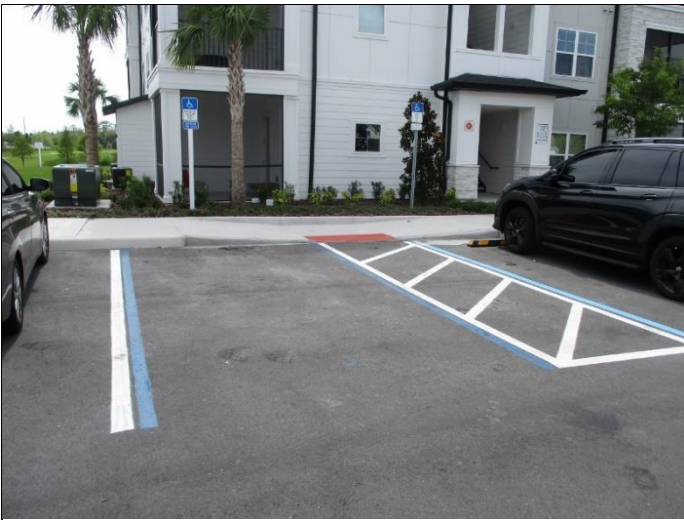
9. Parking pavement markings and signage

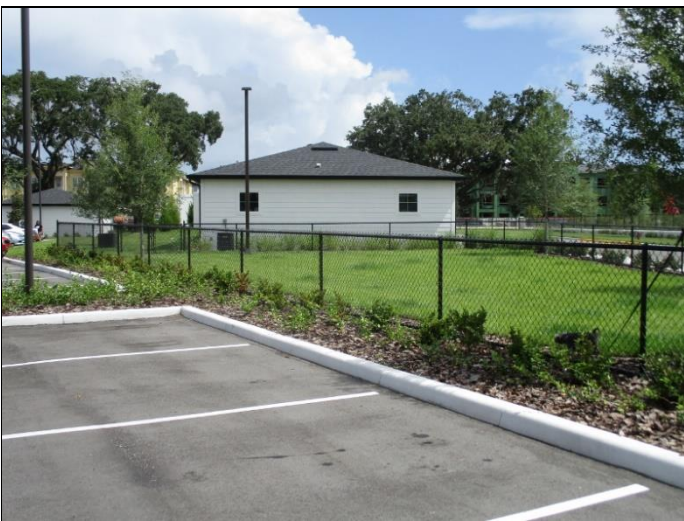
11. Enclosed dog park area

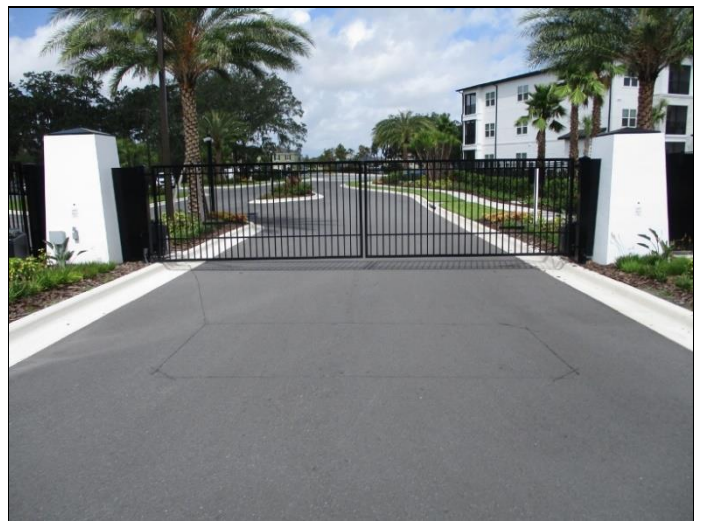
12. Entrance security gates

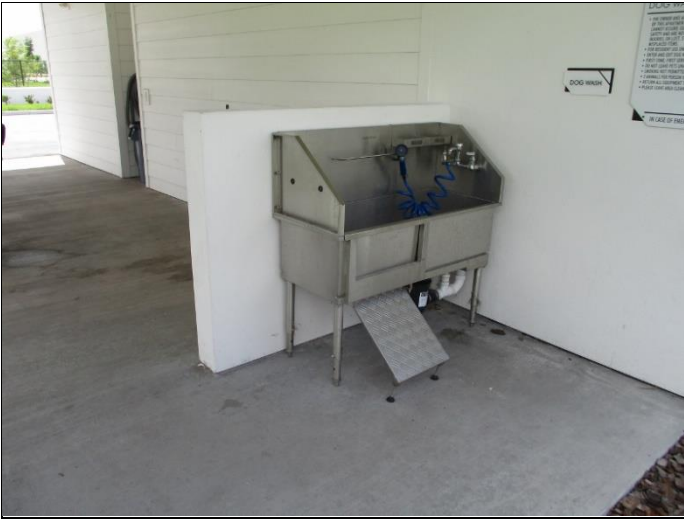
13. Dog wash and car wash stations

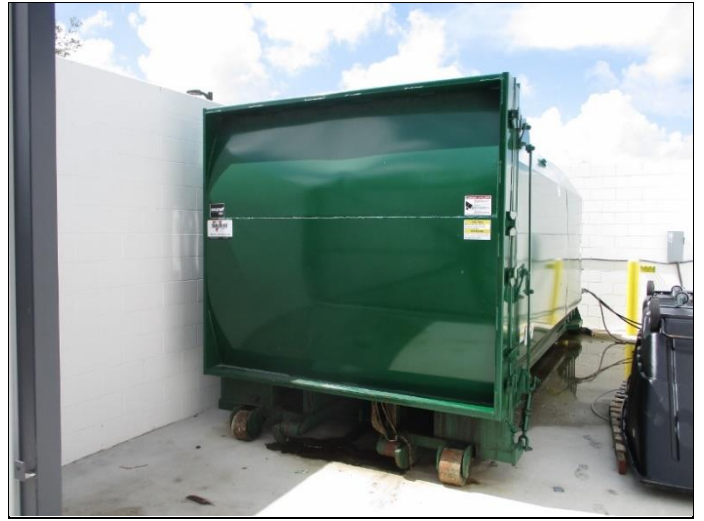
14. Trash compactor at north elevation

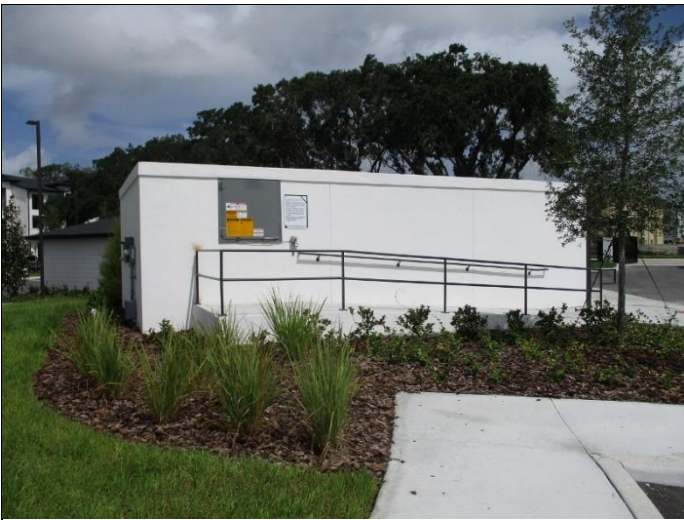
15. Trash compactor enclosure

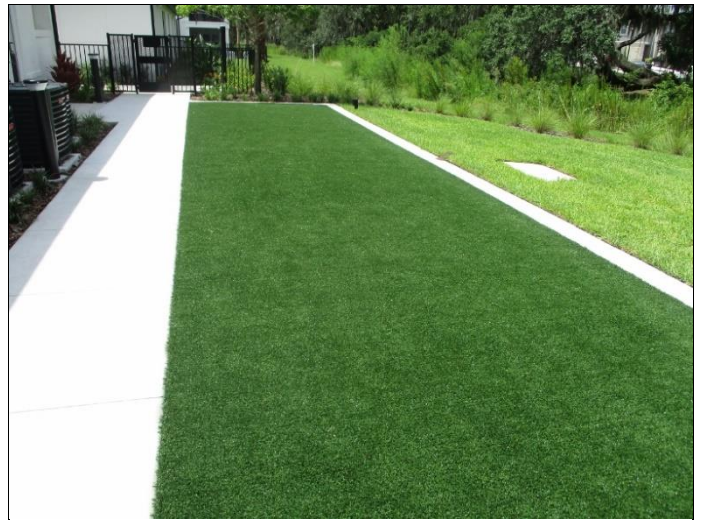
16. Yoga lawn

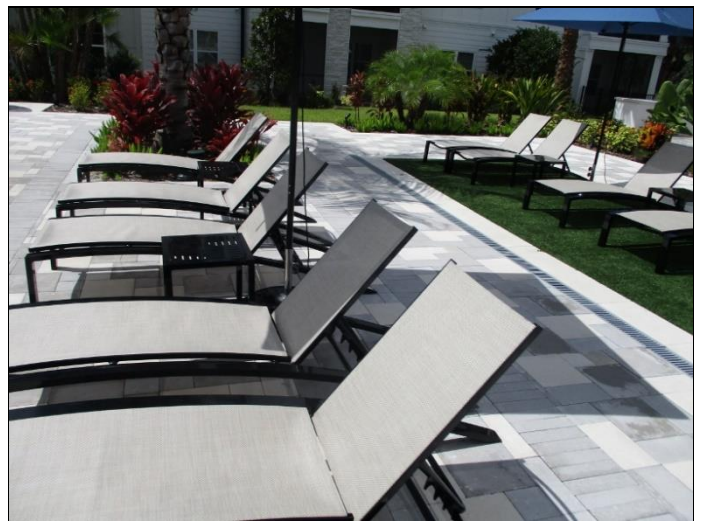
18. Pool furnishings

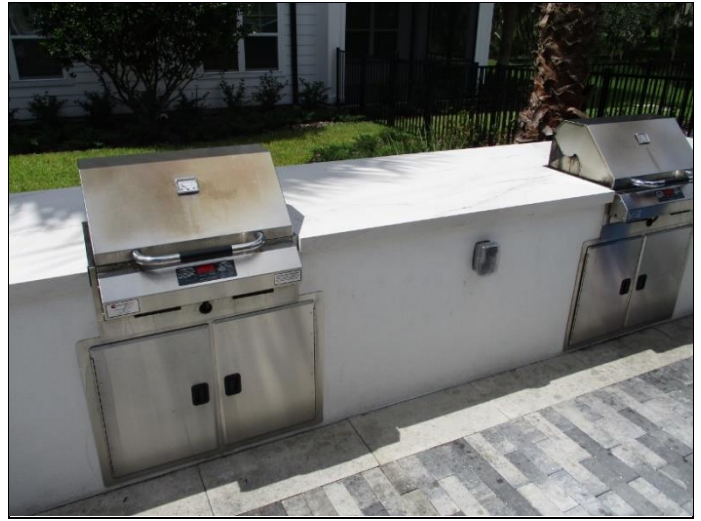
20. Pool barbeque equipment

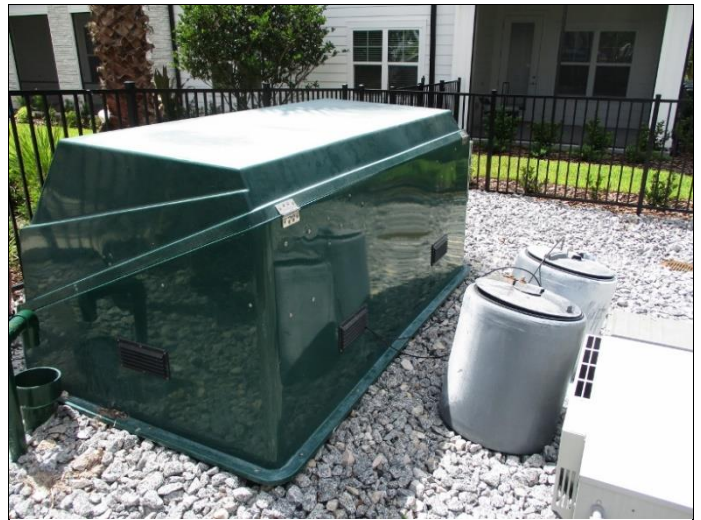
22. Pool equipment enclosure adjacent to pool

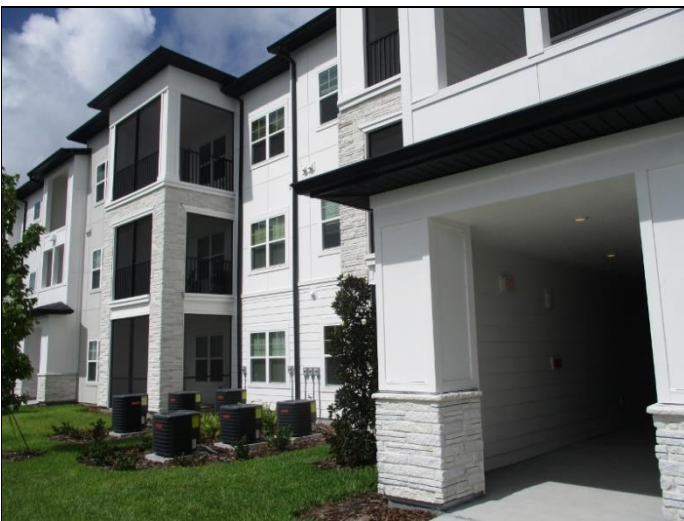
23. Apartment building fiber cement siding and decorative stone accents

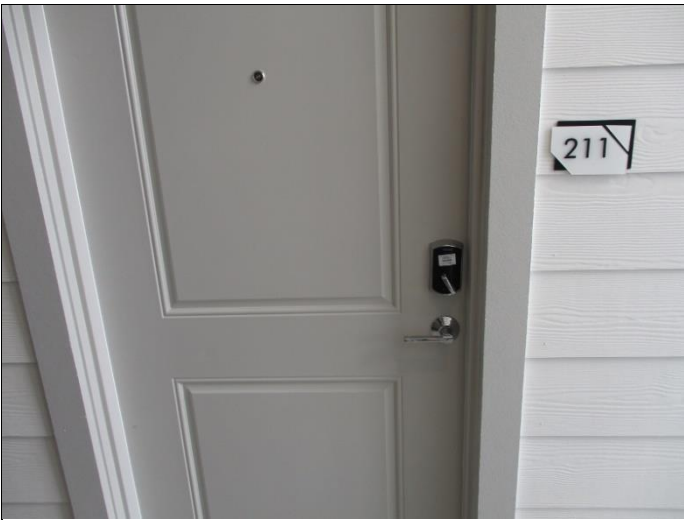
27. Resident entrance door and door equipment

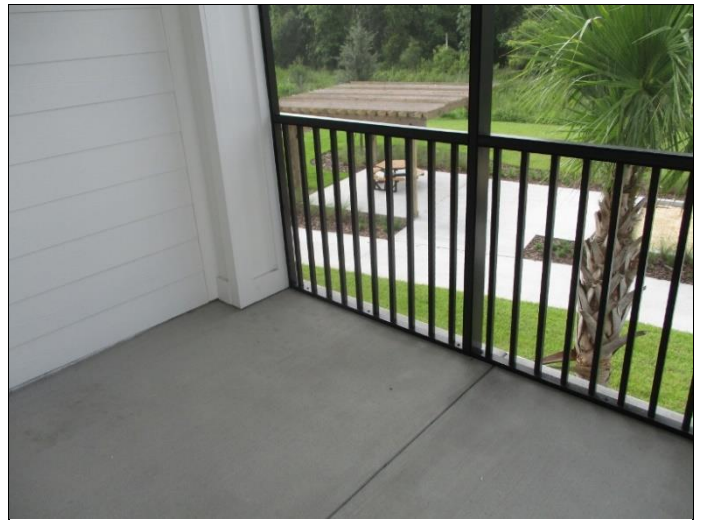
28. Resident balcony

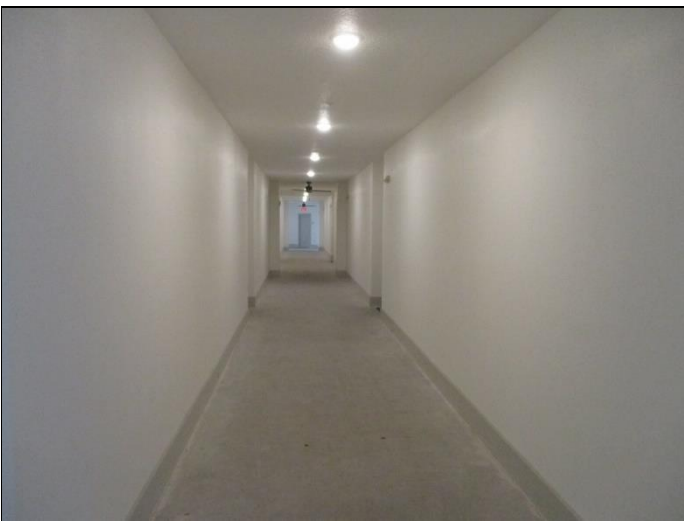
29. Interior breezeways at select building

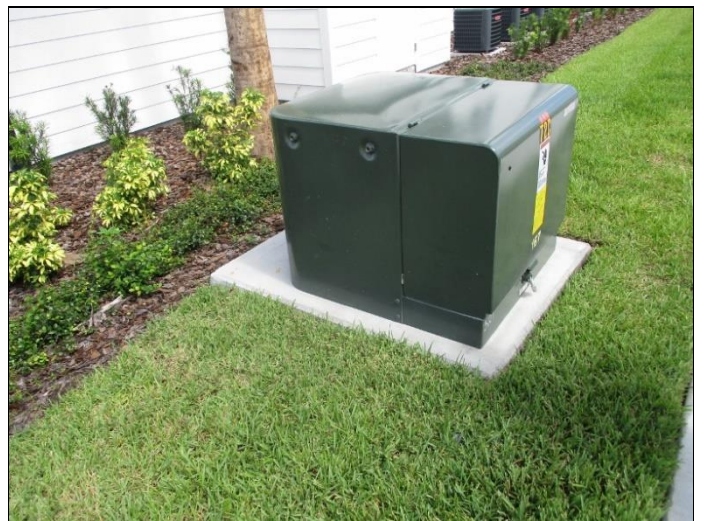
30. Pad-mounted electrical transformers throughout landscape areas

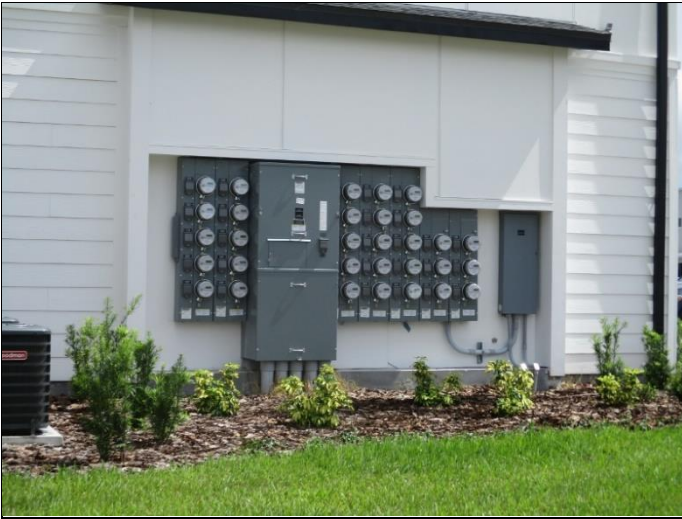
31. Façade-mounted electrical meters

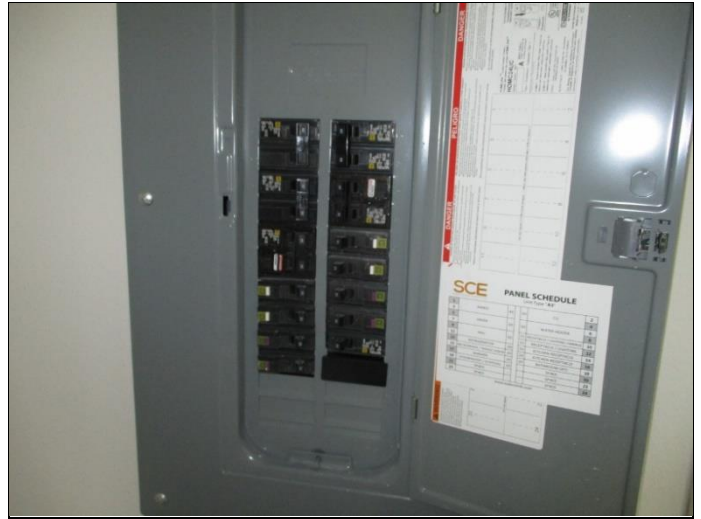
32. Interior unit electric breaker equipment

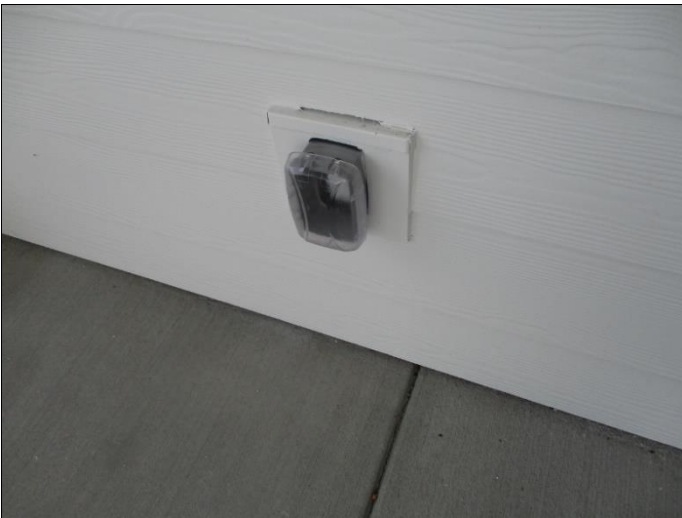
33. Exterior GFCI receptacles inside appropriate housings

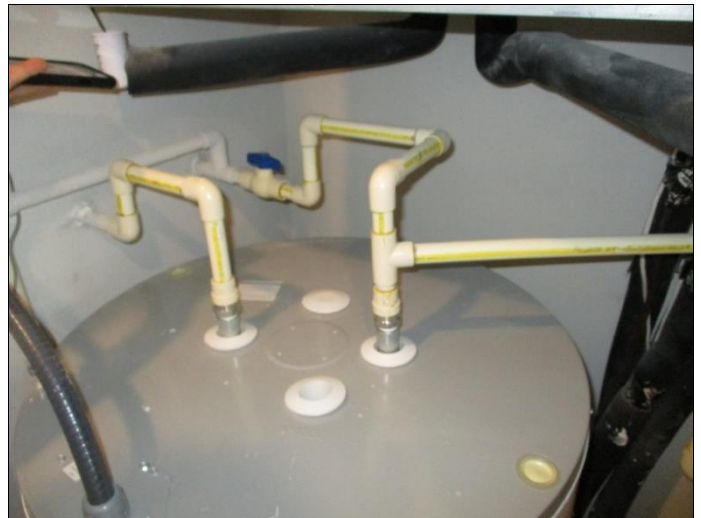
34. CPVC piping observed throughout the subject property

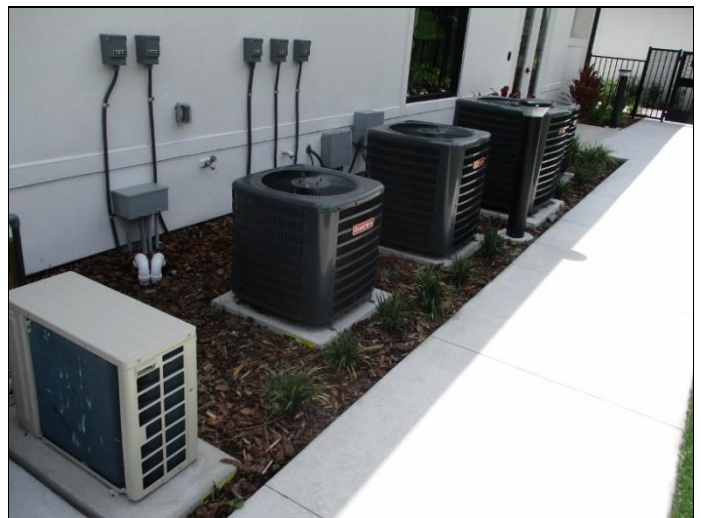
36. Pad-mounted HVAC split system condensers

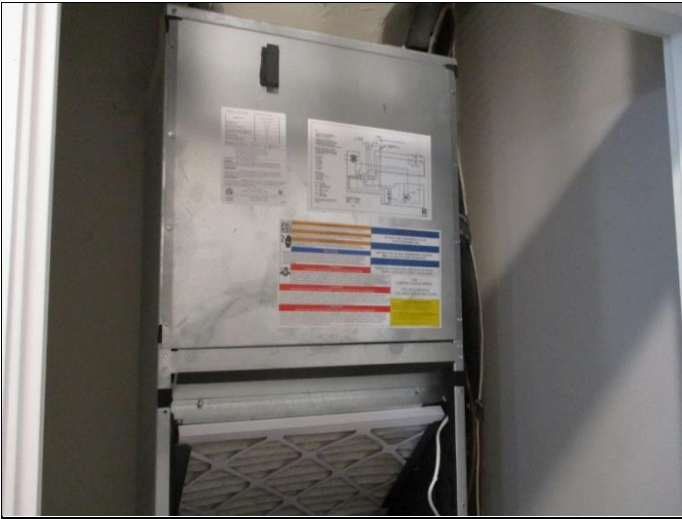
37. Split system air handler unit in mechanical closets in each unit

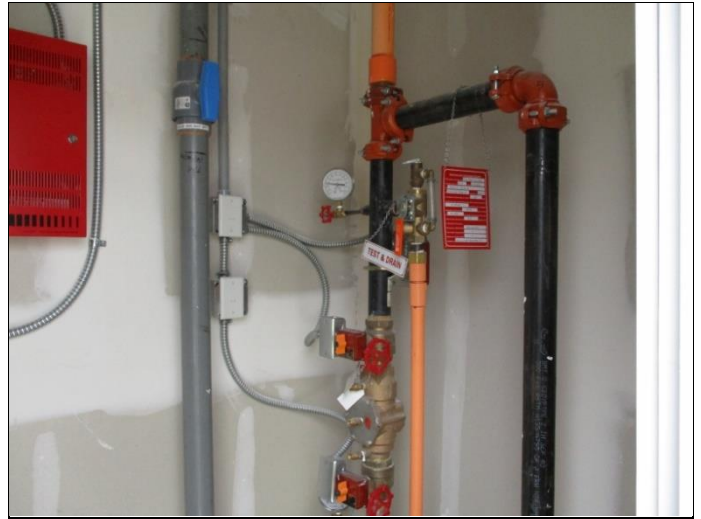
38. Fire sprinkler riser pipe at each building

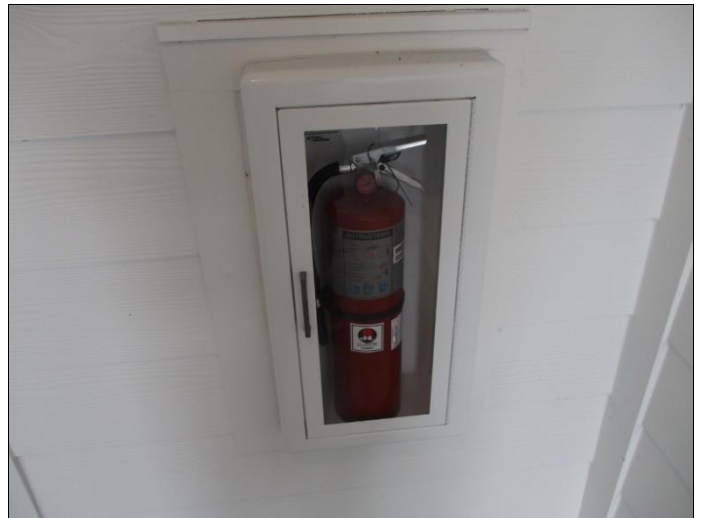
40. Fire extinguishers in mounted enclosures

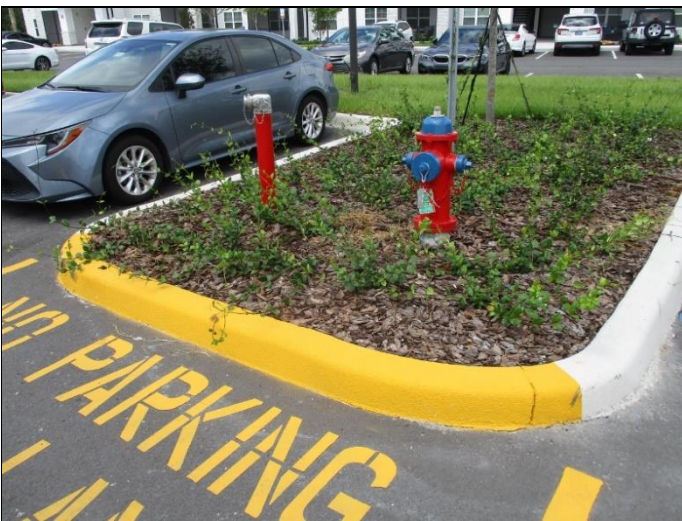
41. Fire hydrant and standpipe connections

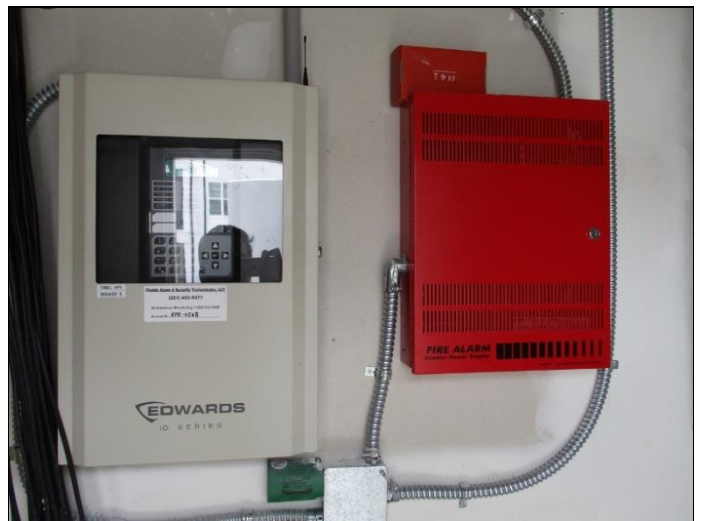
42. Central fire alarm control panel

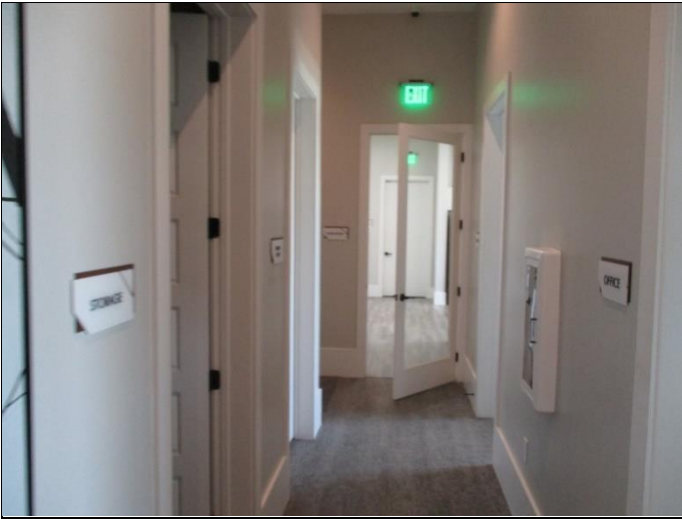
43. Clubhouse hallway finishes

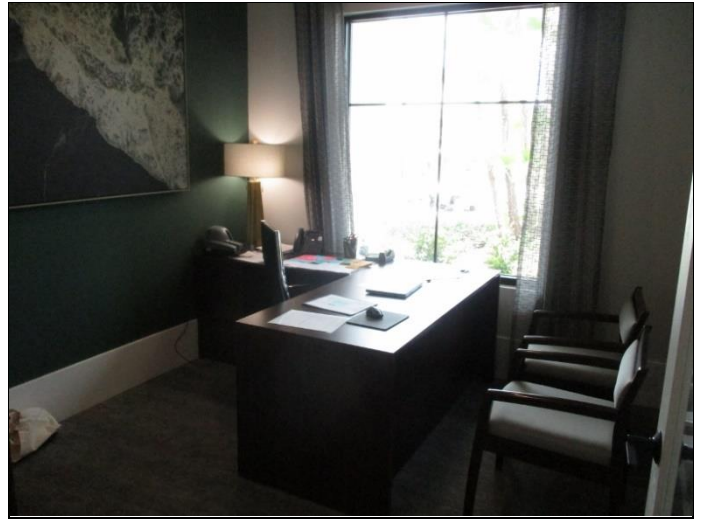
44. Clubhouse leasing offices

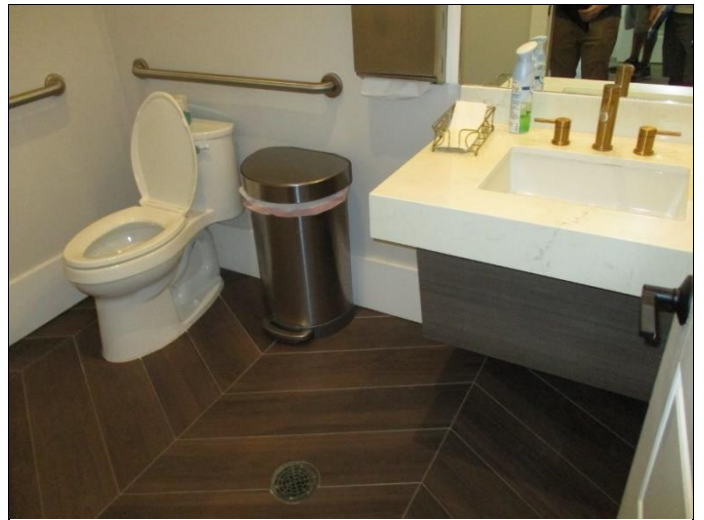
46. Clubhouse restroom

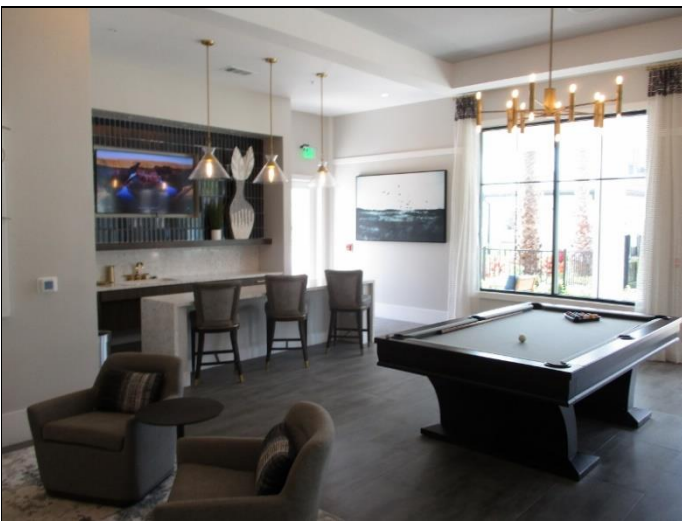
47. Clubhouse lobby area

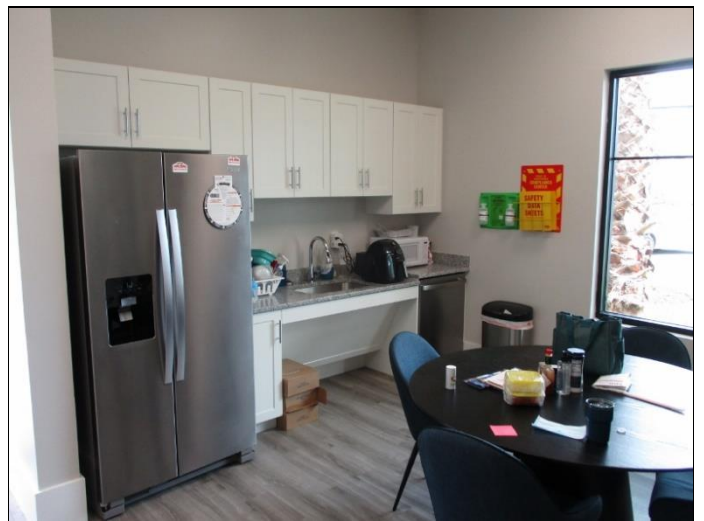
48. Employee break room

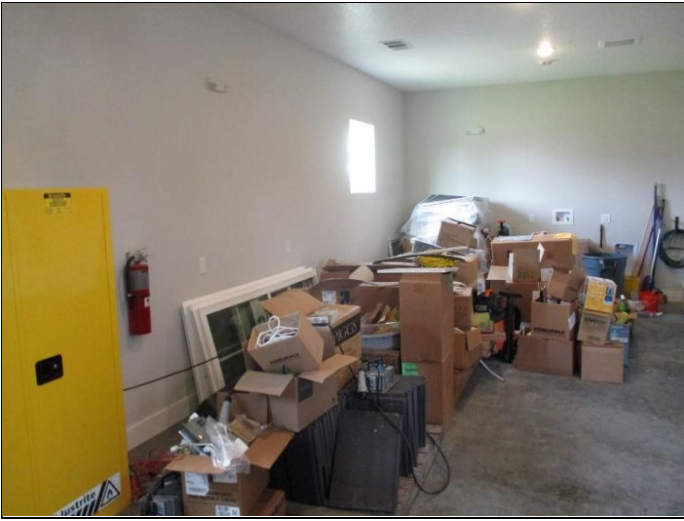
49. Maintenance building interior

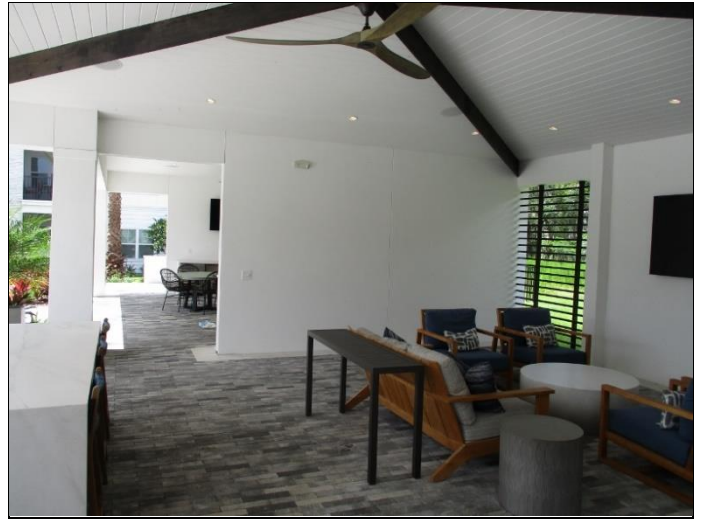
50. Pool deck sitting area

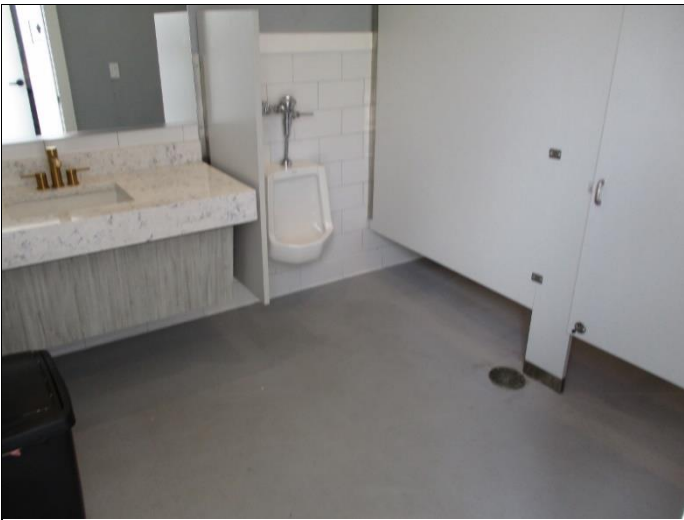
51. Pool restroom area

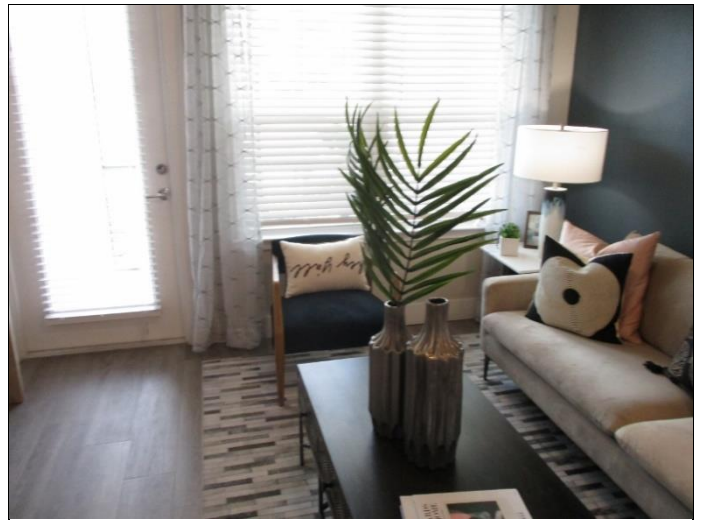
52. Resident living room area

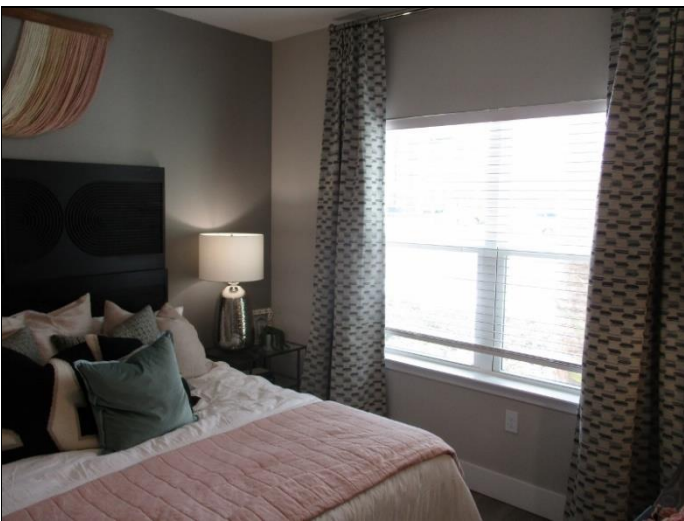
53. Resident bedroom area

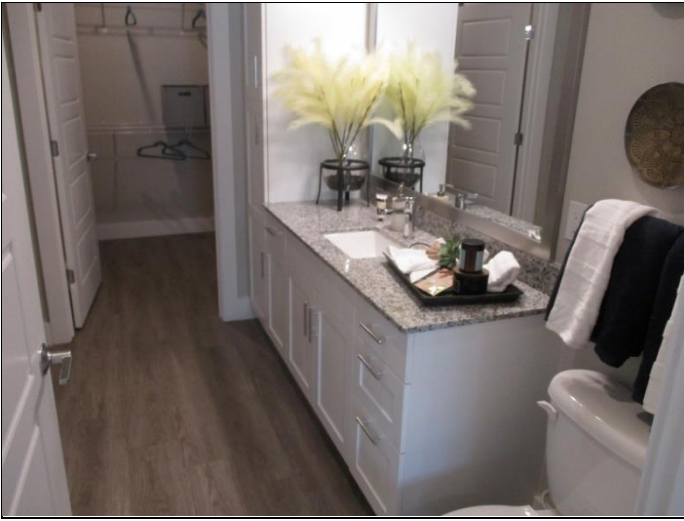
55. Resident bathroom area

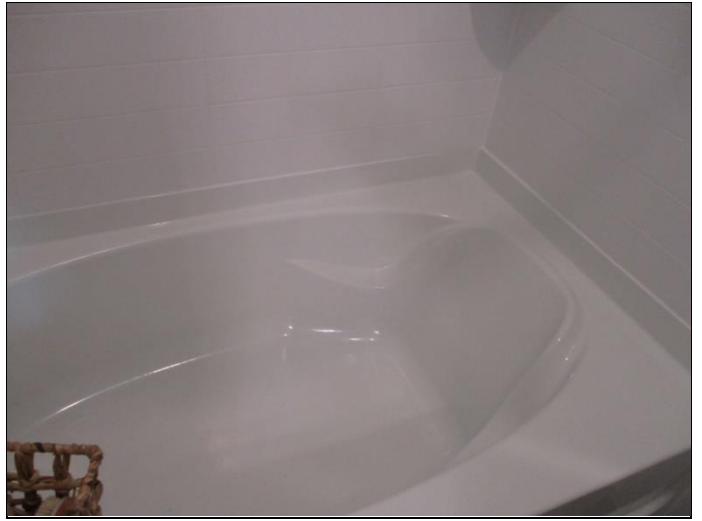
56. Resident bathtub fixture

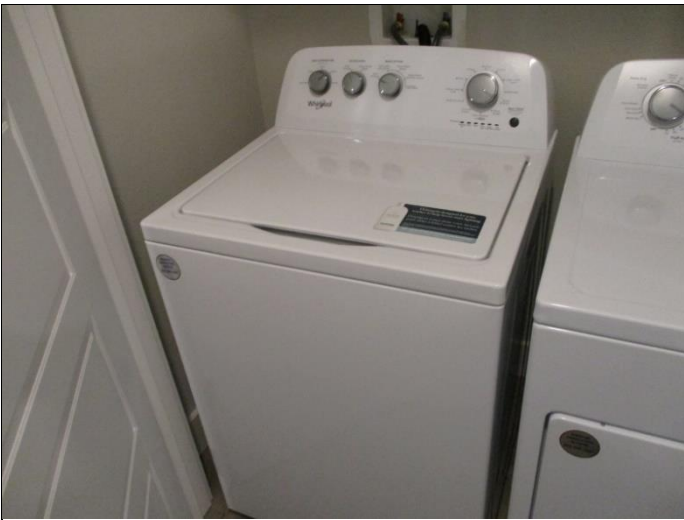
57. Resident washer equipment

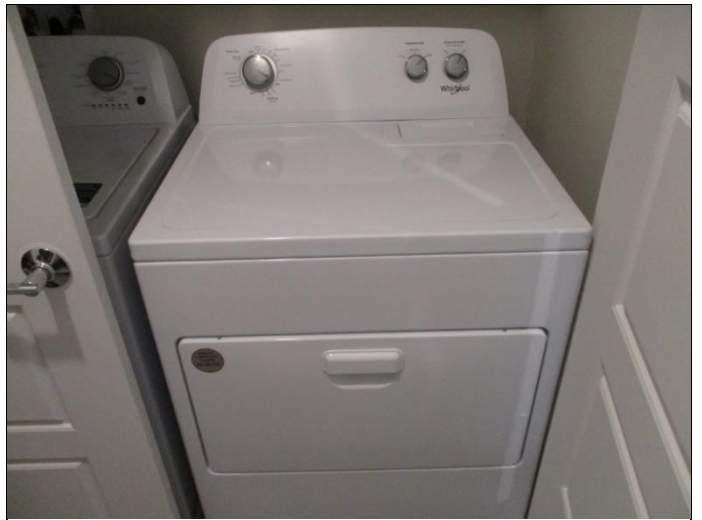
58. Resident dryer equipment

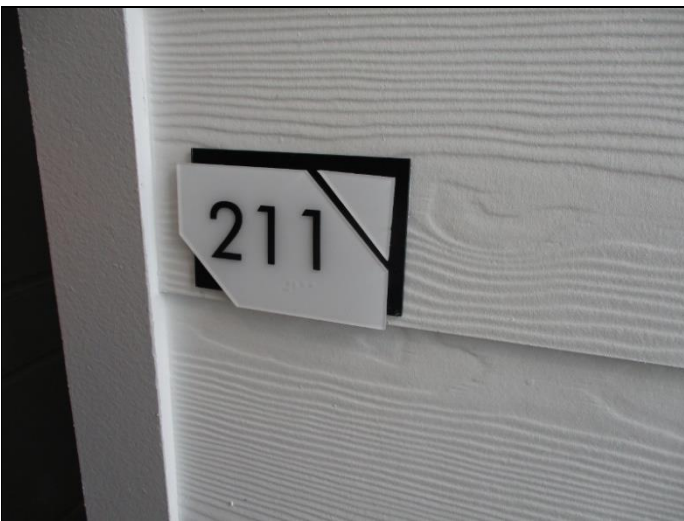
59. Resident room entrance signage

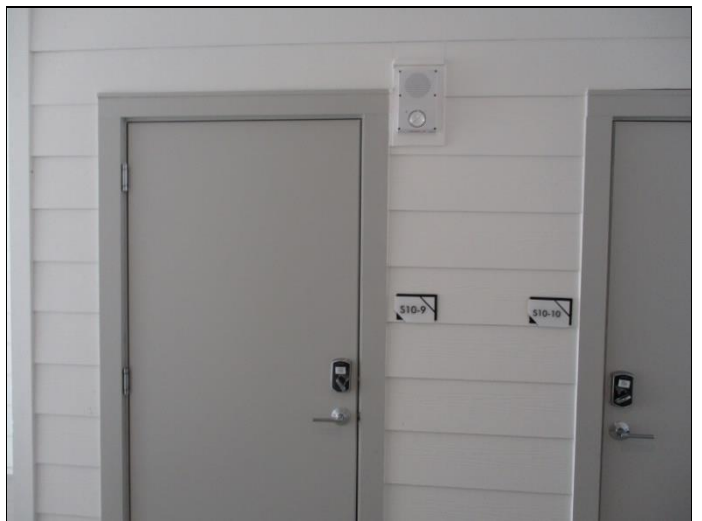
60. Storage units
